PROJECT: COUNTRY CLUB OF DETROIT, GROSSE POINTE FARMS MICHIGAN

FIRM: G2 CONSULTING GROUP ANN ARBOR, MICHIGAN

Deeper Foundations Support New Facilities

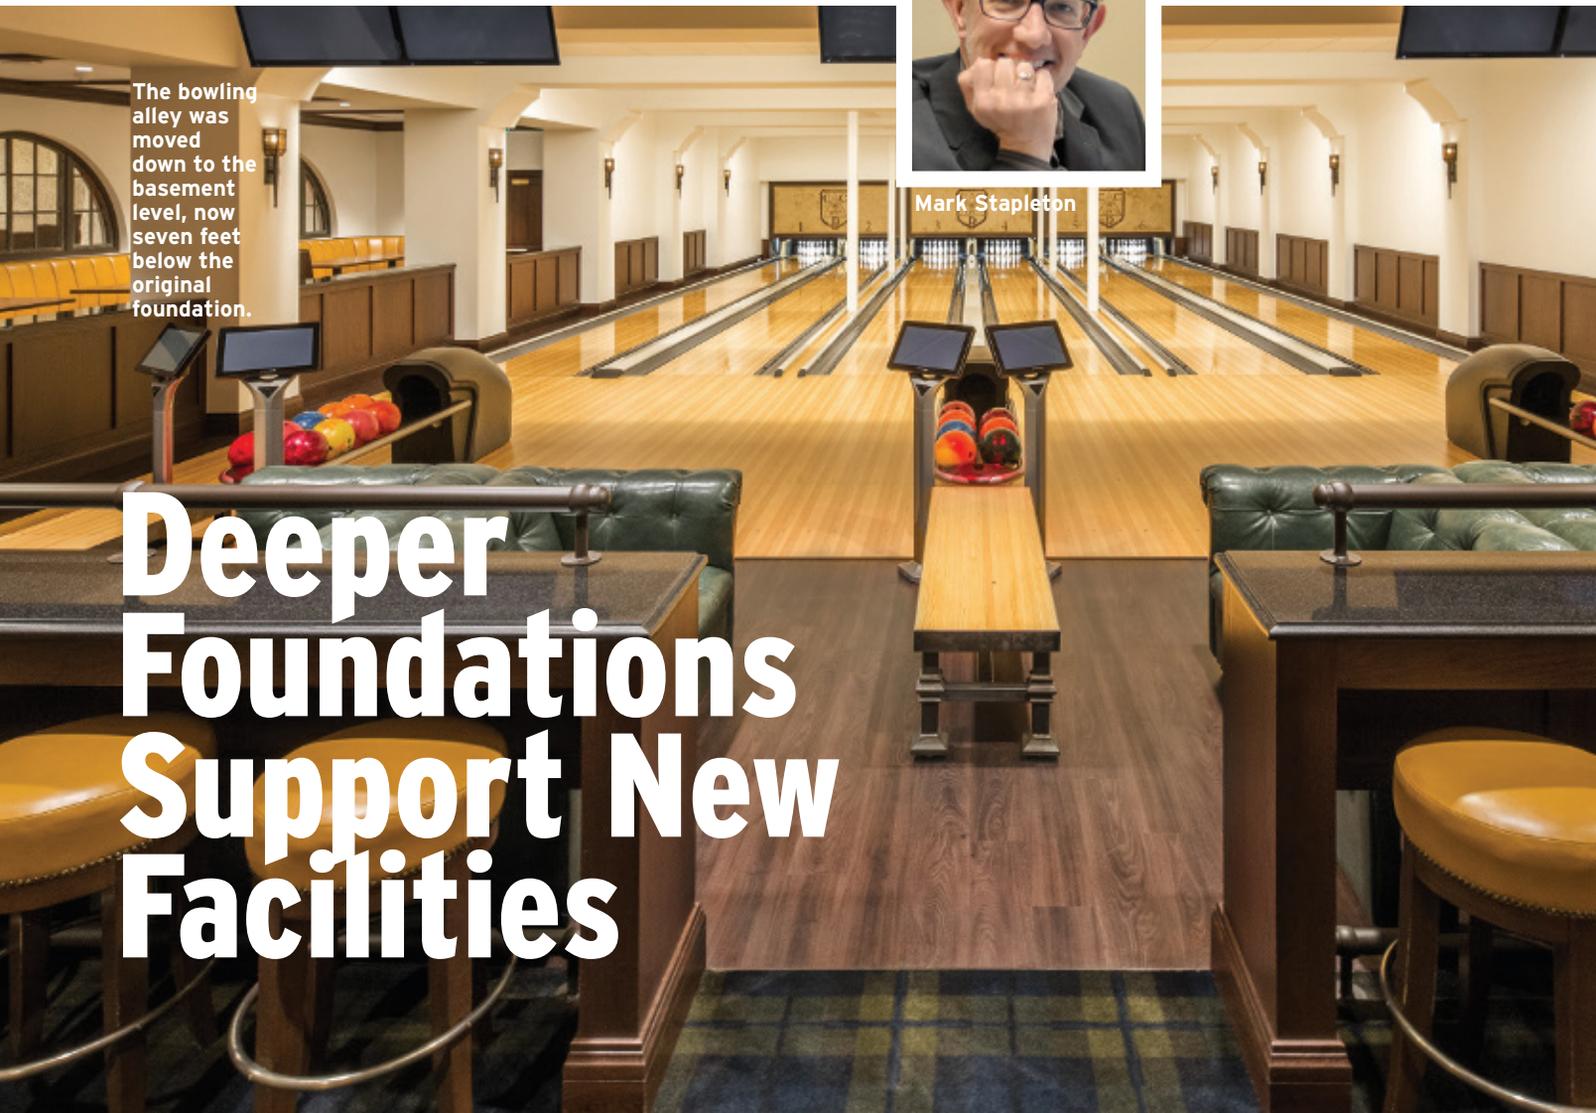
The bowling alley was moved down to the basement level, now seven feet below the original foundation.

Providing the taller ceilings and larger interior spaces in the basement and on the main level meant the bowling alley would be moved seven feet below the existing foundation. The challenge was further complicated by the variability of the soils on-site.

of 120 steel mini piles to underpin the building. Using open cut excavation, the underpinning proceeded in 25-foot increments. Pipe piles attached to the existing foundation were hydraulically pushed down into place, essentially putting each section of the building foundation on stilts while not subjecting the historical structure to damaging vibrations of traditional pile installation.

Concrete foundation walls were then formed and poured to encapsulate the stilts, thus providing stability for the renovations in the short term and adequate bearing for the long term. Throughout the underpinning, sensors monitored foundation displacements, which amounted to only 1/100th of an inch throughout the entire construction process.
